HALIBURTON HIGHLANDS LAND TRUST

Turtle Road Mortality Mitigation Project Newsletter

Final Report Submitted for the HHLT Turtle Road Mortality Mitigation Project

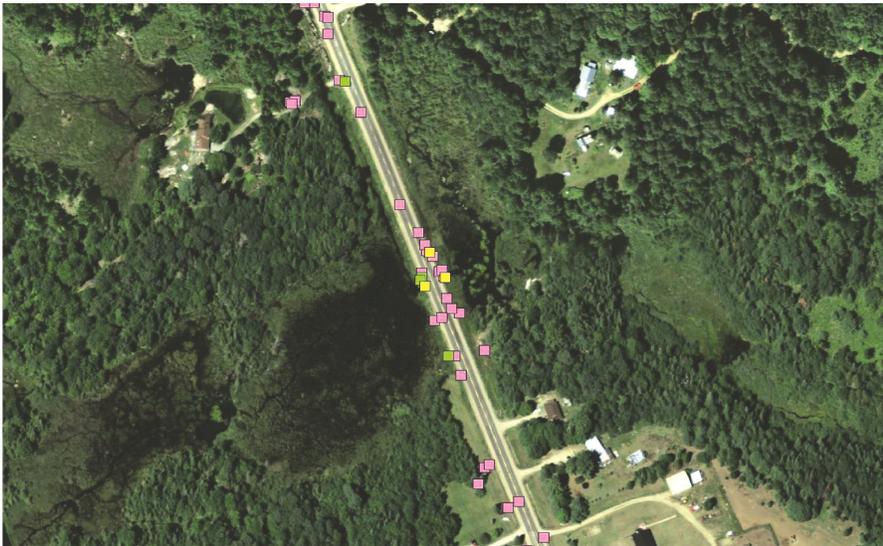
2014 Monitoring Results Prior to Construction at the Gelert Road Test Site

The picture above shows the results of the May / June turtle monitoring program at the test site where construction of the barrier wall adjacent to and existing culvert underpass was to be carried out in the Fall of 2014.

A total of 97 turtles were observed *adjacent to* the roadway, while a total of 53 turtles were observed *on* the roadway. Blanding’s, snapping and painted turtles were among the most prevalently observed species.

The Test Site is located along the Gelert Road which is maintained by the County of Haliburton and is a two lane paved road with a speed limit of 80 km/hr. Traffic along the road is moderate with 66 vehicles per hour.

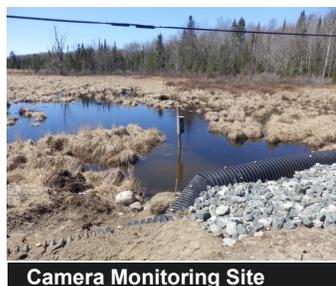
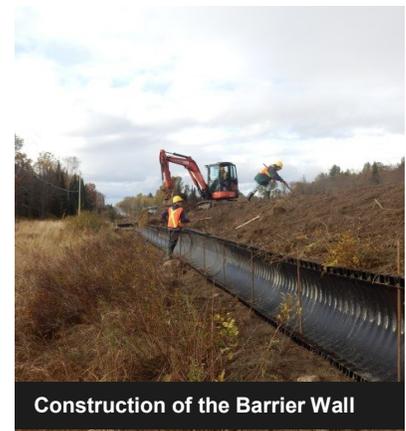
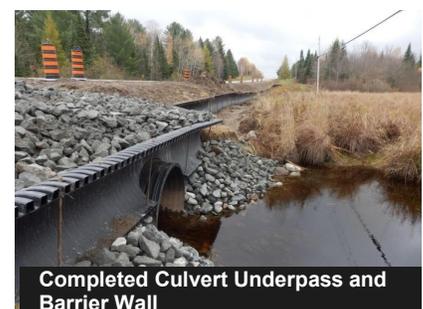
In the Fall of 2014, the barrier wall was constructed adjacent to the existing road culvert underpass at the Gelert Road Test Site.

The barrier wall was designed to prevent the turtles from entering the roadway and to funnel the turtles into the culvert for safe passage under the roadway.

To assist with the monitoring, cameras were installed at either end of the culvert underpass and at the ends of the barrier wall. The cameras were set to begin capturing photographs at 5:00AM and stop at 9:00PM. Over 350,000 photographs were collected in each of 2015 and 2016.

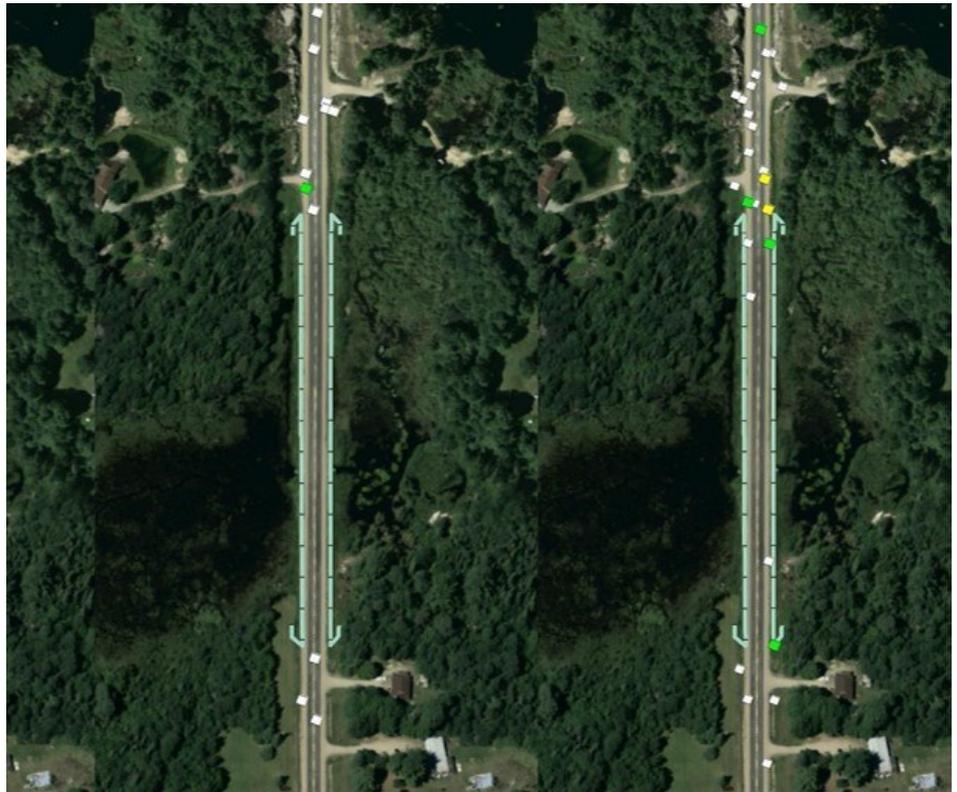
Monitoring Results 2015 and 2016 at the Gelert Road Test Site

Results of the monitoring program over the past two years have been very encouraging. Statistical analysis carried out on the data demonstrated that within the area of the barrier wall and the culvert underpass, very few turtles were able to access the roadway and the number of turtles on the road beyond the barrier wall did not increase from 2014 (see picture above).

Further, with no alternative, turtles were utilizing the existing standard culvert measuring only 1.2 meters across. Sixty turtles were documented making successful passages through the culvert underpass.

Through yearly inspections, it was also determined that the barrier wall as constructed was able to sustain the environmental stresses and was not compromised in the two years of monitoring.

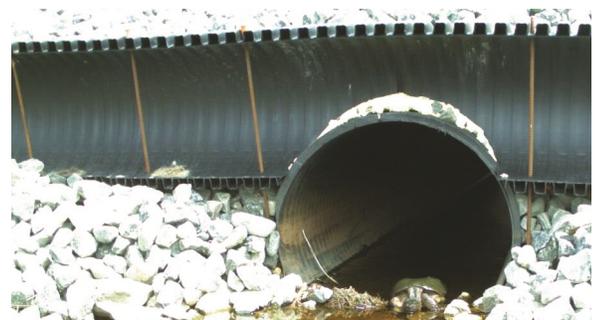
Snapping Turtle Emerges from the Culvert Underpass
